**AMERICAN EEL ABUNDANCE AND DISTRIBUTION ALONG THE SPILLWAYS OF
THE LAKE WATEREE DAM ON THE WATEREE RIVER AND THE COLUMBIA
DAM ON THE BROAD RIVER**

COMPLETION REPORT

MARCH 31, 2013

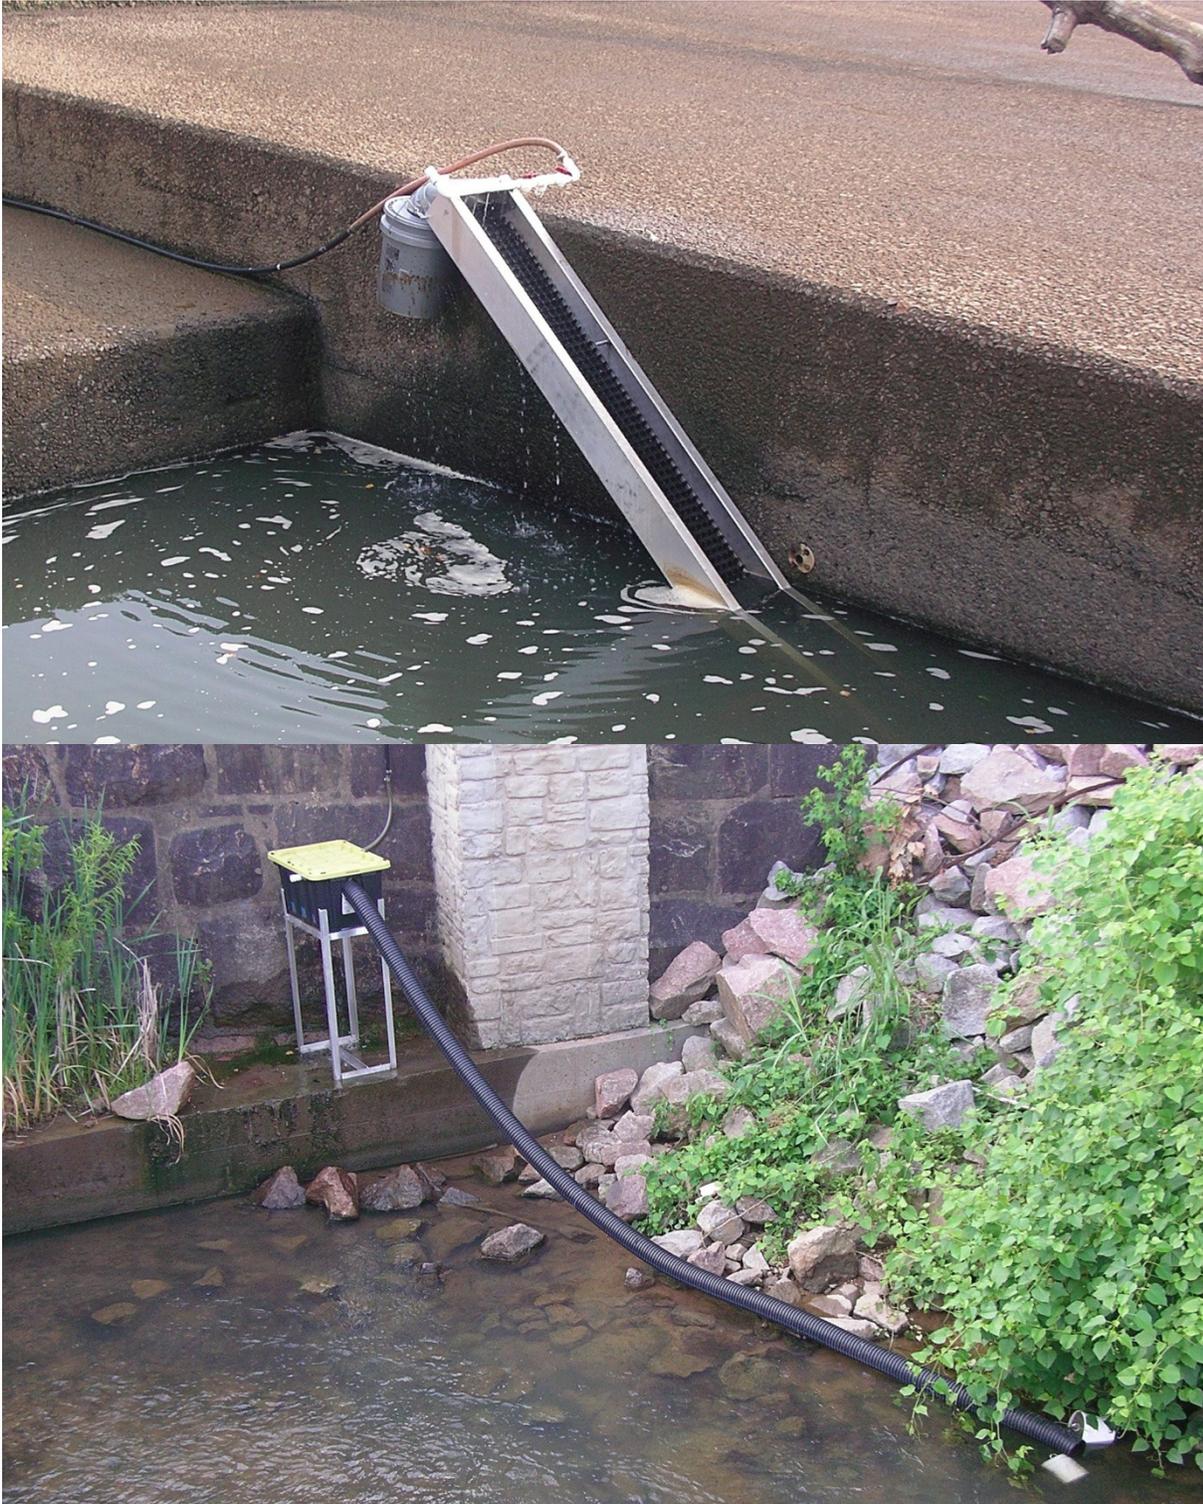
Figure 1. Ramp trap (top panel) and box-style trap (bottom panel) installed at Columbia Dam, South Carolina.

The design of the ramp traps was similar to those that worked very well at Roanoke Rapids, North Carolina (Dominion 2009). Ramp traps were constructed from $\frac{3}{4}$ inch plywood, or aluminum cable trays, and ranged from roughly 7 ft to 13 ft in length and were 12 inches wide. The ramp deck was covered with 1-in polyethylene Akwadrain strip drain (AWD, Inc., Monroe, North Carolina) and terminated at a covered collection bucket (Figure 1). Water was supplied to each ramp and collection bucket through gravity fed supply lines. Attraction flow was added to ramp traps at Wateree Dam during 2011 by adding an additional water supply line to each trap that gently agitated the water surface at the ramp entrance. The entrance to each trap was submerged at all water generation levels.

Three ramp traps were installed at Wateree Dam during spring 2010 and a fourth trap, trap 0, was added during 2011 (Figure 2). At Columbia Dam 3 ramp traps were installed during spring 2010 and a fourth trap, a box-style, trap was added during 2011 (Figures 1 and 2), during 2012 this box style trap was removed and replaced with a ramp trap. During 2011 all the ramp

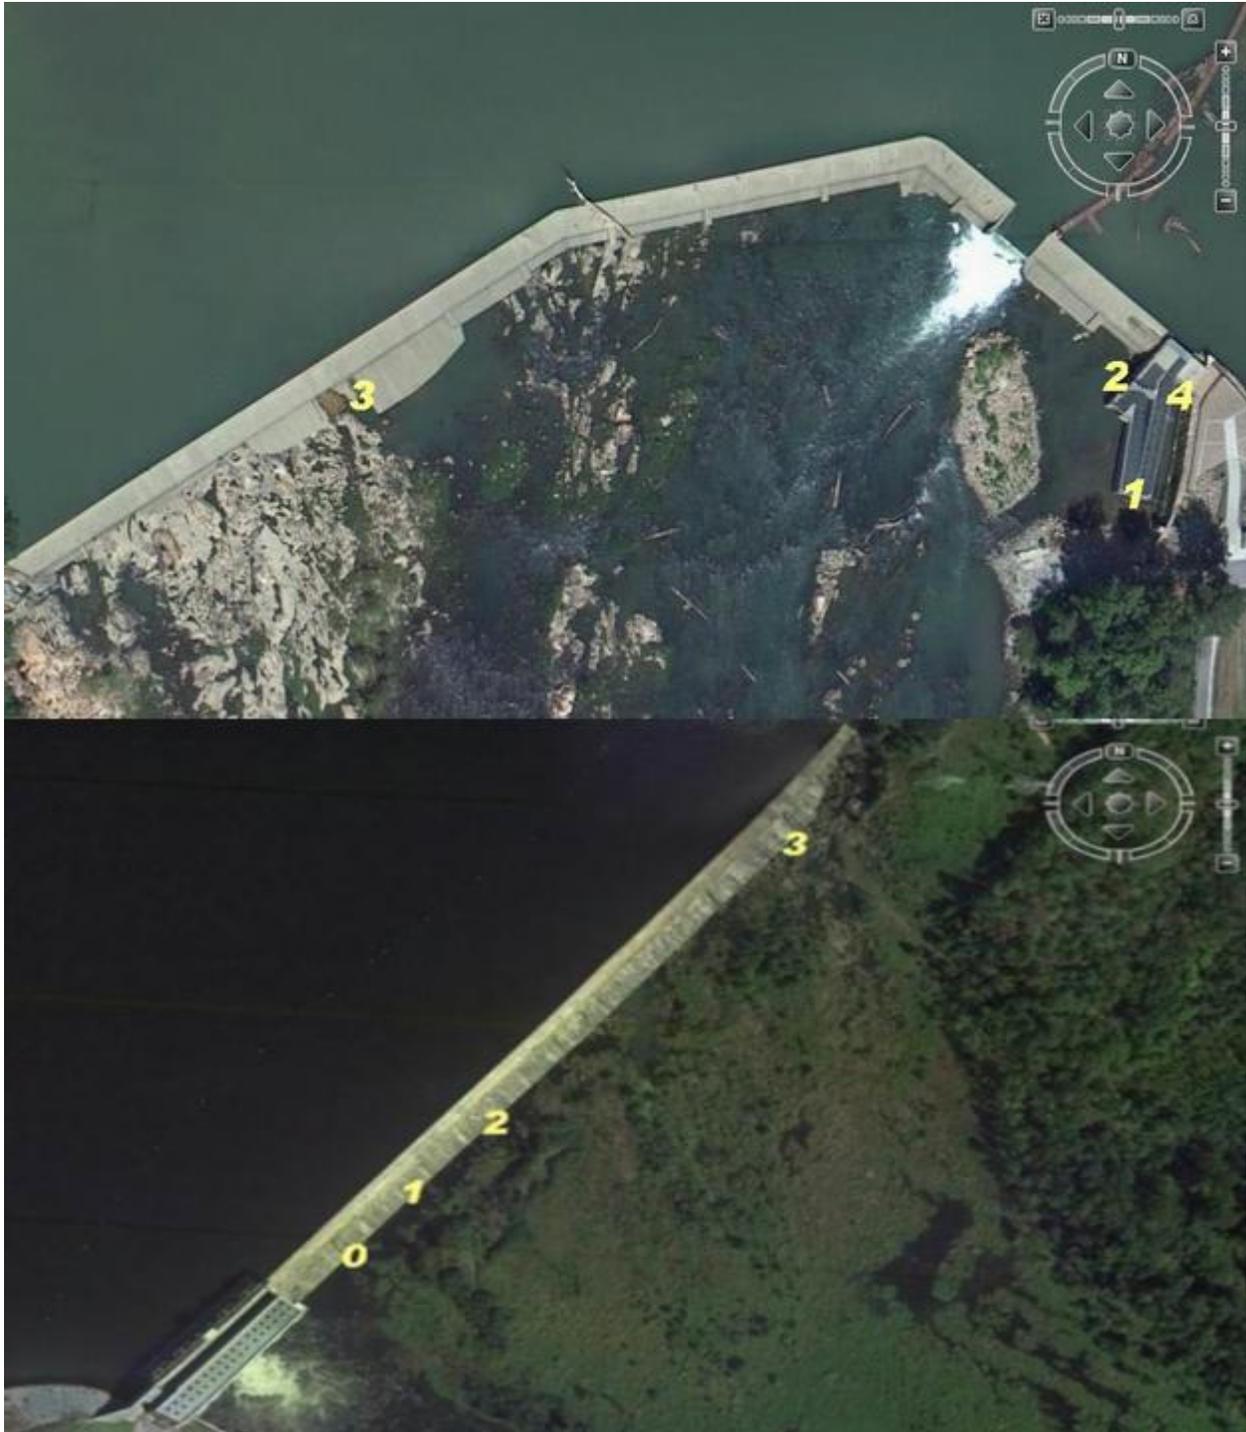
Figure 2. Eel ramp trap locations at Columbia Dam (top panel) and Wateree Dam (bottom panel) during 2012.

All eels collected from Wateree Dam were captured on the west side of the spillway near the powerhouse in ramps 0 – 2; no eels were captured from ramp 3 on the east side of the Dam. At Columbia Dam all eels were captured on the east side of the dam near the fish passage facility at ramp locations 1 and 4, and the Fukui trap that was located near ramp 1.
